# DWR Update - Subsidence

Roy Hull, Engineering Geologist  
CA Department of Water Resources

*Groundwater and Geologic Investigations Section  
Northern Region Office, Red Bluff*

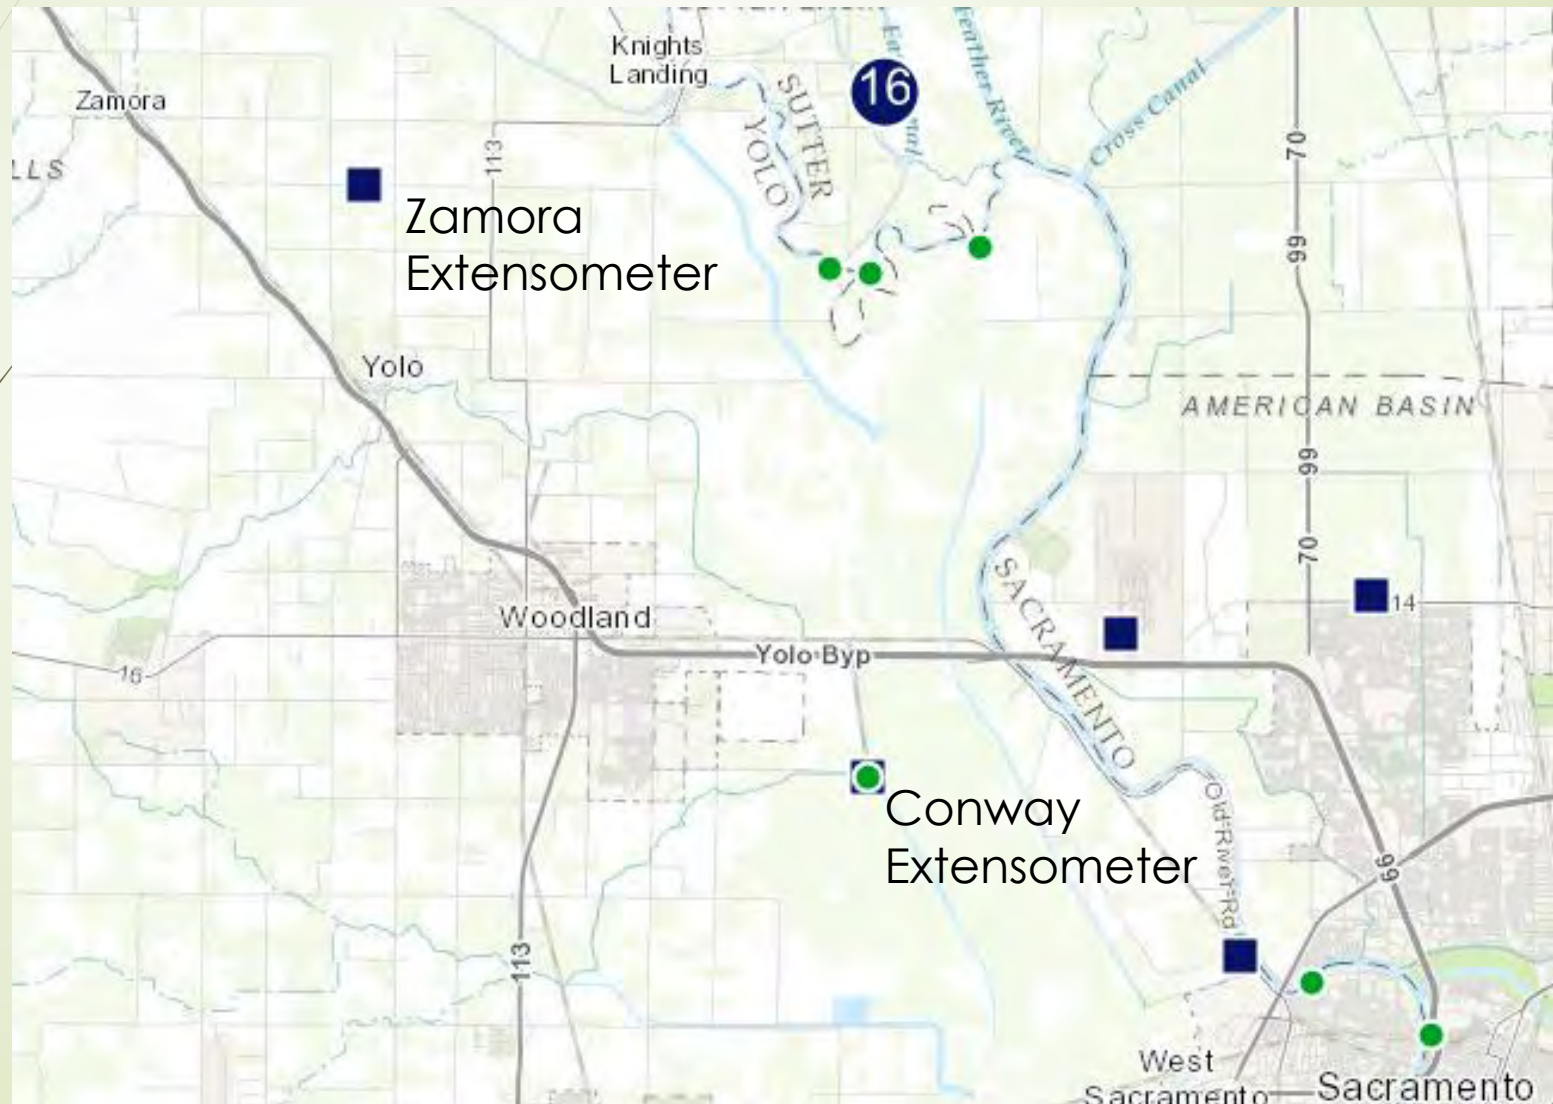
# Recorded inelastic subsidence in Yolo County

# Yolo County
